# LESSONS LEARNT FALL FROM ALLOY TOWER

## BACKGROUND

On 14 August 2026 at approximately 13:40, an apprentice electrician fell when a MiTOWER mobile access tower overturned during CCTV conduit installation in the ground-floor commercial unit.

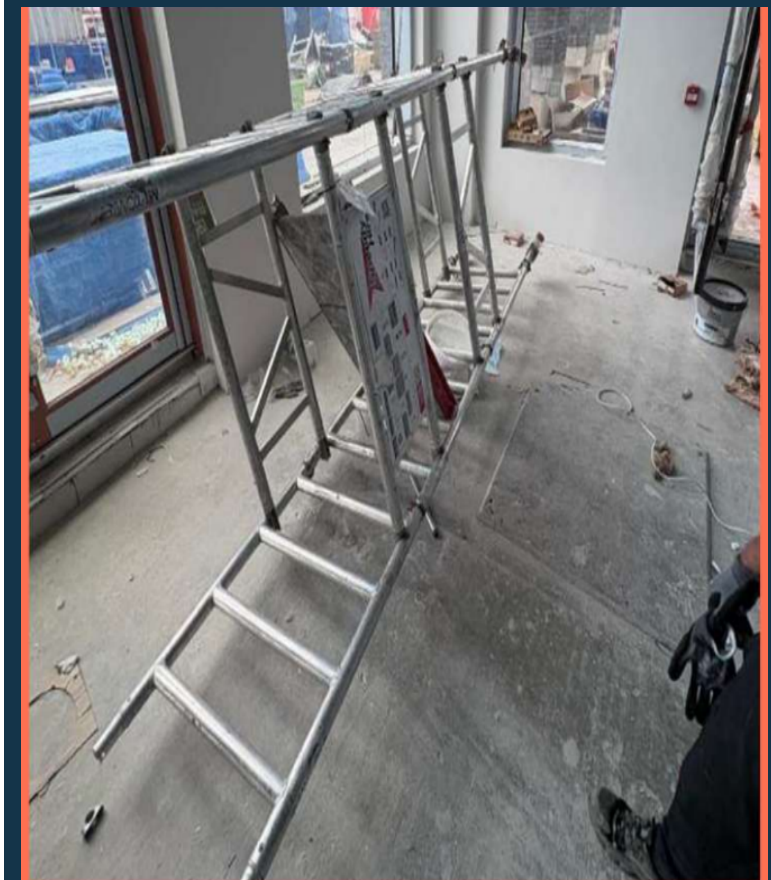
The Site Manager had three opportunities to check the tower - at the start of the shift, during the work and before completion - but did not identify the missing stabilisers.

The trained Site Manager did not verify that the tower had been erected in accordance with the manufacturer's instructions before work started.

Available PASMA competence was not used to positively verify the tower configuration before use.
